Manhole Inspection Summary

Manhole # S21I__015MH

Insp Date: **9/21/07 10:08 AM**

Location Address: **35 ADDISON ST**

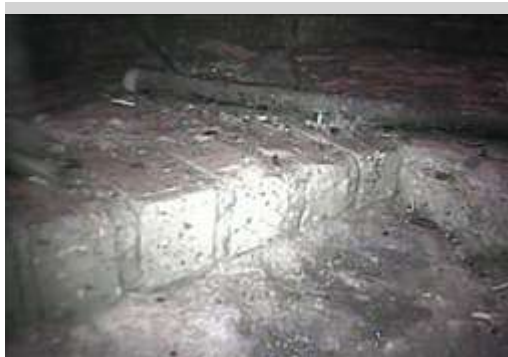
Defect 5

DEBRIS IN CHANNEL AND ON BENCH

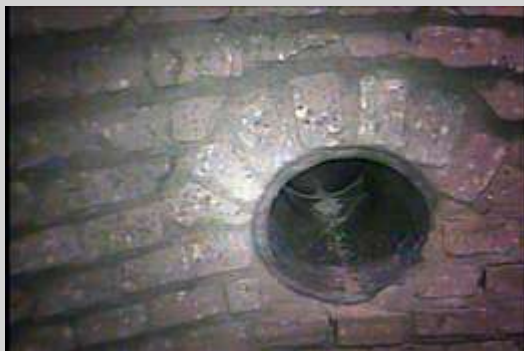
3 O'Clock Inflow

DETERIORATED BENCH
